United States Department of the Interior

NATIONAL PARK SERVICE
Water Resources Division - PEB
P.O. Box 25287
Denver, CO 80225

Subject: Travel Report. Geomorphic assessment of Big Sandy Creek, Sand Creek Massacre National Historic Site (SAND) May 18-20, 2011

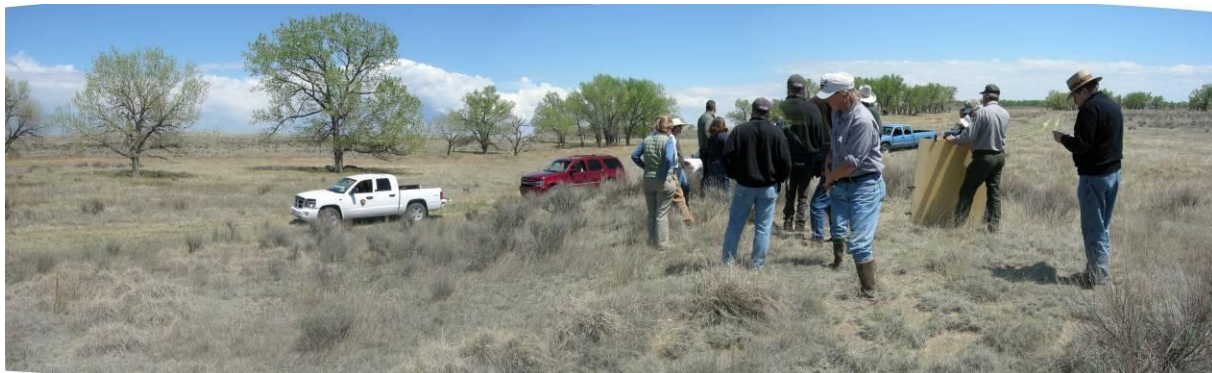
Figure 1 - Standing on the man-made levee (at the mouth of the Chivington Canal) across from one hypothesized encampment location

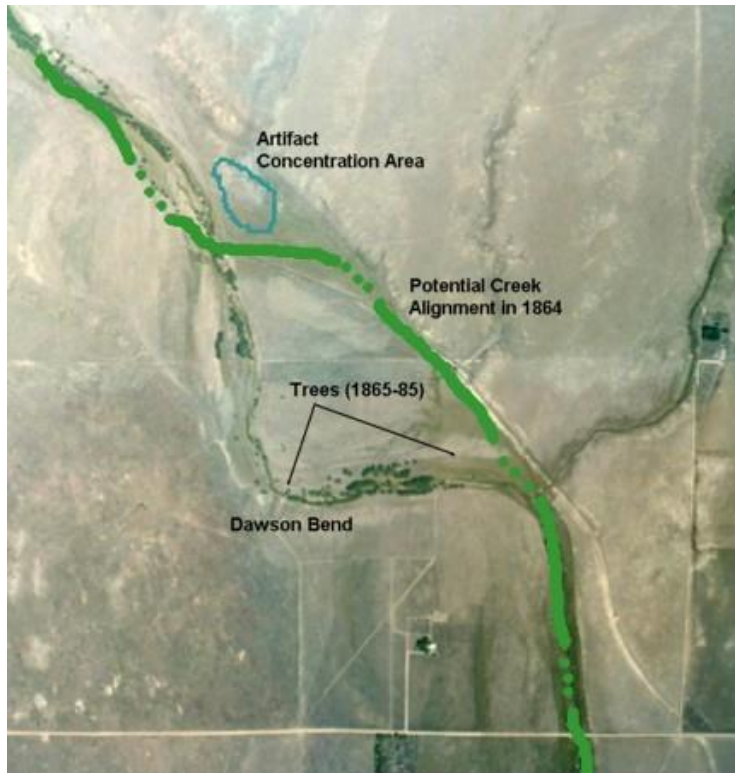
Figure 2 – Aerial photograph of the study site with the present day channel and a potential former channel alignment (green)

A concentration of artifacts was found about 0.6 mile north of the existing Dawson Bend (please see figure 2). The location of the artifacts was hypothesized to be an alternative location of the tribal encampment. Some of the historic data suggest that the encampment was close to a bend in the active channel. If the concentration of artifacts represents the location of the encampment, then

The NPS found a concentration of artifacts in an area on the northern edge of the Dawson Bend floodplain which they interpreted to be the encampment area (please see figure 2 above). However, the tribes determined the George Bent map to be of greater evidence that shows the layout of the camp within a bend that looks very much like the current Dawson Bend. Therefore, the tribes and the NPS were 0.6 mile apart in their interpretations of where the camp was located. The enormously important thing here is that if the camp was where the artifacts were found, if the current Dawson Bend wasn't there in 1864, and if the bend was further north on the west side of the artifact area (as shown in Figure 2), then it means that the artifacts do indicate the camp location relative to George Bent's map that shows the camp within a creek bend. Therefore, determining the location or configuration of the 1864 channel, using geomorphological data, could be important to defining the encampment location. Knowing the position of the encampment is also important to developing interpretive programs and media and to the development of an accurate General Management Plan.

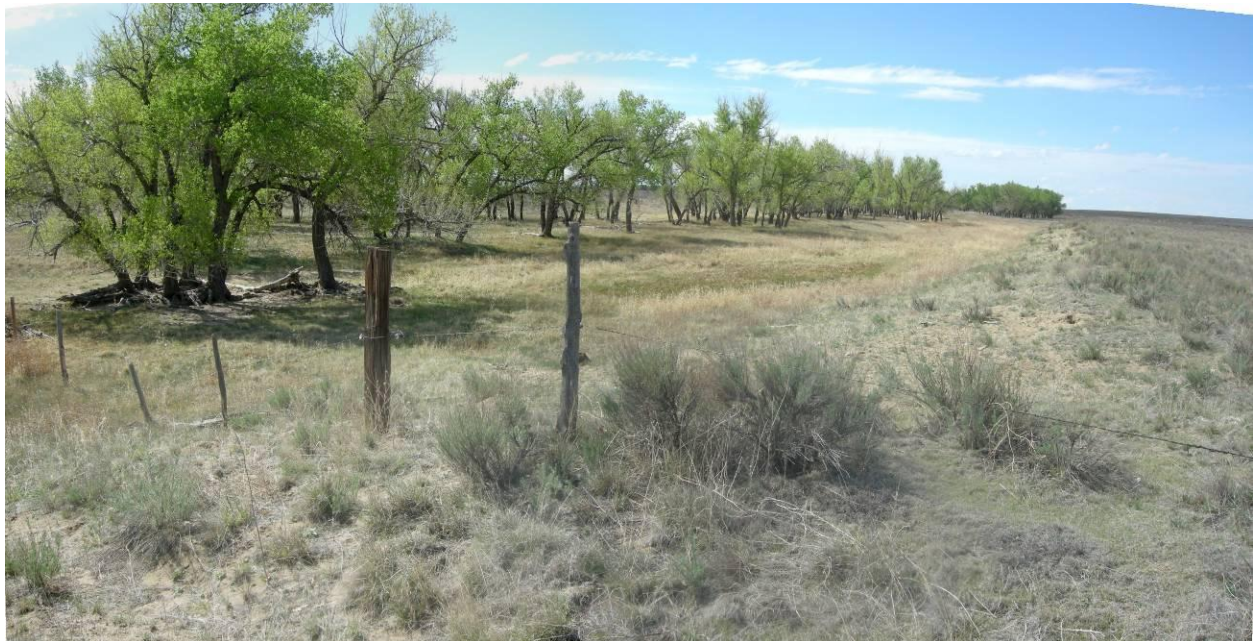
Figure 3 - Looking north along the east side of Big Sandy Creek channel between Dawson Bend and the inlet to the Chivington Canal. Note the low area on the left with Cottonwoods (modern floodplain), the poorly defined channel in the middle (T0), and the higher terrace on the right with sage brush (presumed to be T1). The sagebrush covered terrace is continuous in the northern direction for about 1500 feet; it is very well formed and very well preserved with no evidence of former abandoned channels.
